STRUCTURAL ANALYSIS OF BULKHEAD PATCH REPAIR DUE TO HEAT DAMAGE

The integrity of the aircraft structure after a permanent repair requires thorough engineering analysis. In this study, the aircraft's defective Bulkhead was damaged due to heat exposure and repaired with a patching technique known as a bulkhead patch repair. The study aimed to analyse the repair carried out using numerical calculation and finite element analysis. The first result of the numerical calculation shows that the repair part (stainless steel) will restore the original part (AA7050) strength capability. The second result from the LS-Dyna analysis shows that heat damage had caused the material (AA7050) strength to deteriorate significantly. The final loads testing using LS-Dyna analysis on components shows the patch repair scheme conducted could strengthen the damaged part by transferring the applied loads to repair part. The outcome of this study justified that for better maintenance action (structural integrity consideration), the damaged Y453 Bulkhead needed to be replaced instead of conducting permanent repair.

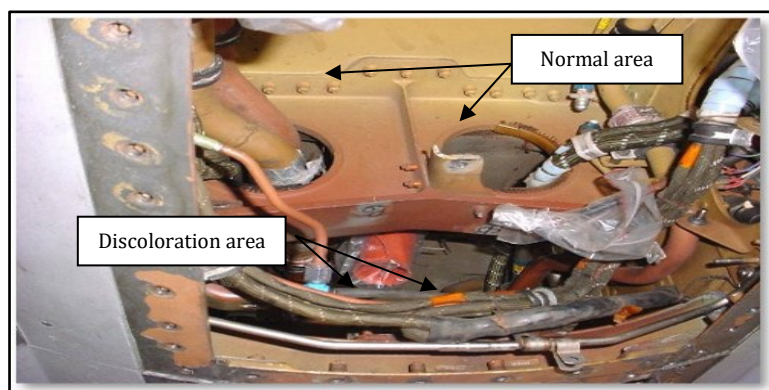
In a comparative study done on the variety of aluminium alloy material, there was a drop of 90% of the material's tensile strength when exposed to temperature elevated from room temperature till 370°C for 0.5-hour exposure [7]. This effect will reduce the operational capability of the component. Figure 2 shows the impact on heat damage based on discoloration. The effect of temperature on the aluminium structure will reduce the structure's operational capability by softening strain hardened and redistributing local stress in creep [8]. Creep is defined as a process of material deform permanently due to mechanical stress [9]. It occurs due to a high level of stress but still below the yield strength of the materials. For example, when subjected to heat for a long period, creep always increase with temperature increases. Stages of creep can be divided into three developments [10-11]; primary creep, which happens at a fast rate, secondary creep, which occurs at a steady pace and tertiary creep happens rapidly and rupture to failure. The author also mentioned that the creep generally happened at 30% to 40% of the materials melting temperature. For records, the melting temperature of aluminium alloy is in the range of 475 °C to 675 °C.

Figure 2. Heat damage on AA7075 Y453 bulkhead

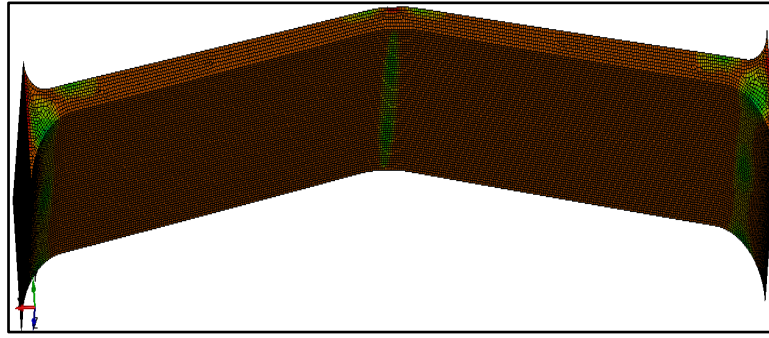
The effects of the elevated temperature on the original structure of AA7050 using the simulation are shown in Figure 8. This condition can be compared with the actual condition in Figure 9. The obvious effect was that the real structure was having discolouration and so as the simulation result. This can be defined as the depletion of strength due to elevated temperature.

Figure 8. Heat damage simulation result

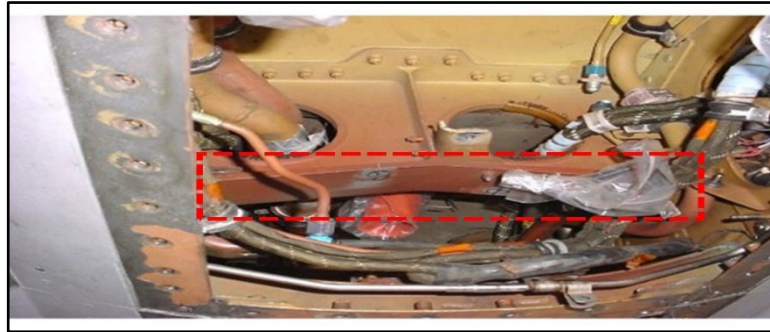
Figure 9. Actual condition

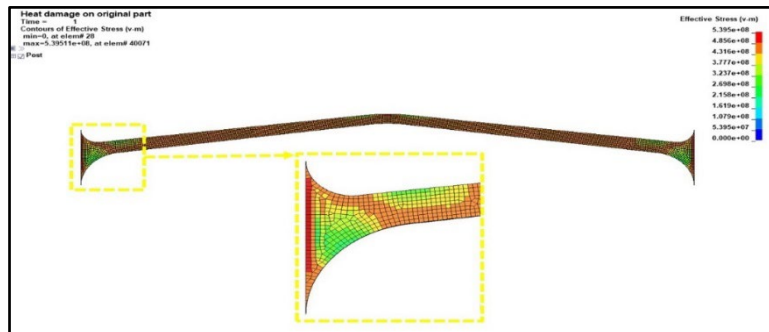
The highest stress was recorded on the areas of fix joints, whereas the heat effect had caused repel force due to fix conditions. The highest effective stress (Von-Mises Stress) recorded as shown in Figure 10 is $\sigma_{vm} = 539.5 \text{ MPa}$, while the yield strength of the material was only $\sigma_y = 441.3 \text{ MPa}$. Thus, the material of original structure (AA7050) had failed due to σ_{vm} higher than σ_y ($\sigma_{vm} > \sigma_y$). The expansion due to heat on original structure is about 0.38 mm in horizontal direction as shown in Figure 11.

Figure 10. Heat effects on effective stress

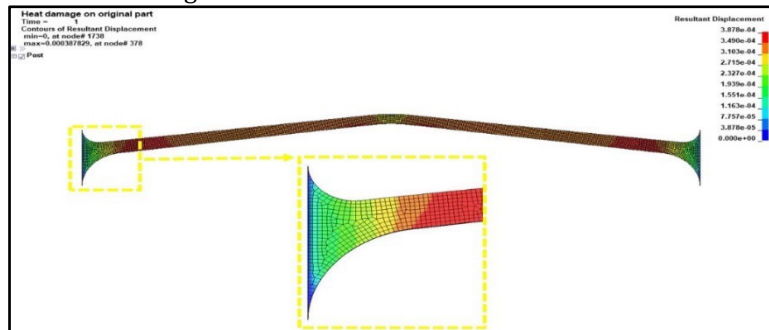
Figure 11. Heat effects on resultant displacement

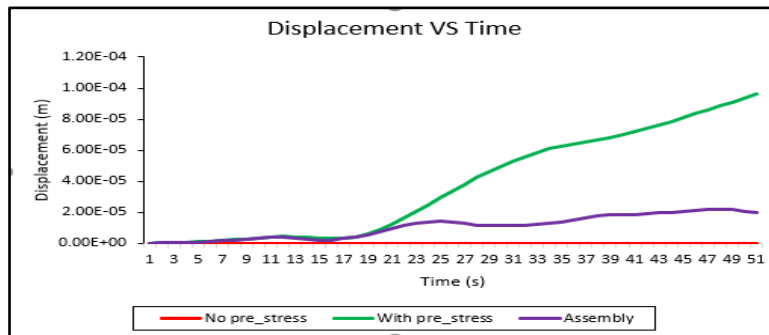
Figure 16. Displacement vs time for the structure

As per Figure 16, the red graph was steady with zero displacement, due to the load applied of 40kN could not cause any displacement to the original part. Then on the green graph, the displacement incremental was the highest when used with the same load, as the material's strength had been depleted to absorb the same load. And lastly, with an additional attachment of the repair part to the damaged part, on the purple graph, the displacement incremental was lower than the green graph but still showed deformation. This can be explained that the damaged structure is transferring the load to the repair part, thus reducing the displacement effects.

be carried out. This is based on the facts that the repair assembly shows capability degradation in the same applied load and creep deformation is already happening on the structure.
