STRUCTURAL ANALYSIS OF BULKHEAD PATCH REPAIR DUE TO HEAT DAMAGE

The integrity of the aircraft structure after a permanent repair requires thorough engineering analysis. In this study, the aircraft's defective Bulkhead was damaged due to heat exposure and repaired with a patching technique known as a bulkhead patch repair. The study aimed to analyse the repair carried out using numerical calculation and finite element analysis. The first result of the numerical calculation shows that the repair part (stainless steel) will restore the original part (AA7050) strength capability. The second result from the LS-Dyna analysis shows that heat damage had caused the material (AA7050) strength to deteriorate significantly. The final loads testing using LS-Dyna analysis on components shows the patch repair scheme conducted could strengthen the damaged part by transferring the applied loads to repair part. The outcome of this study justified that for better maintenance action (structural integrity consideration), the damaged Y453 Bulkhead needed to be replaced instead of conducting permanent repair.

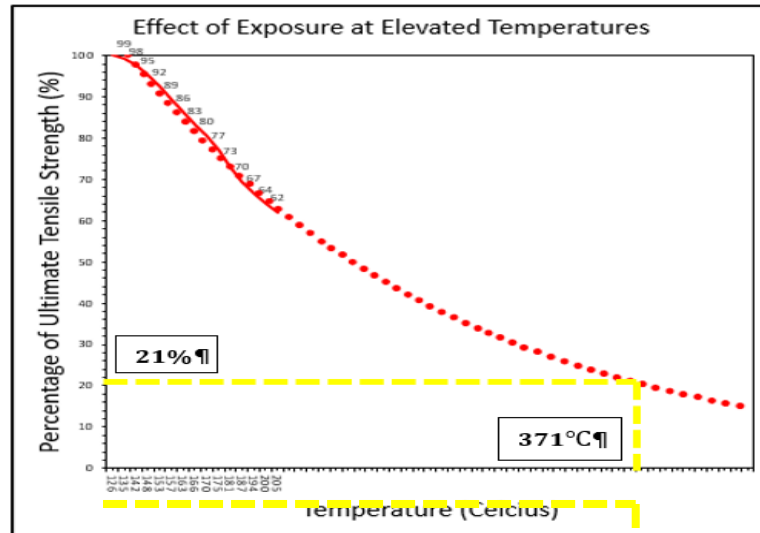
Figure 12. Effect of exposure on elevated temperature [11]

The outcome of the simulation does not directly show the strength of the affected structure. The resultant strength can be defined using an experiment by estimation from the graph of the effect of exposure at the elevated temperature [11]. The graph in Figure 12 shows the estimate tensile strength left after the heat damage. Based on graph extrapolation of 371 C effects, the strength was just 21% of the actual tensile strength. Thus, in this case the actual tensile strength was $\sigma_t = 510.2$ MPa, then if only 21% of the tensile strength left, the strength of the AA7050 after heat damage will be $\sigma_{t_new} = 102.04$ MPa.

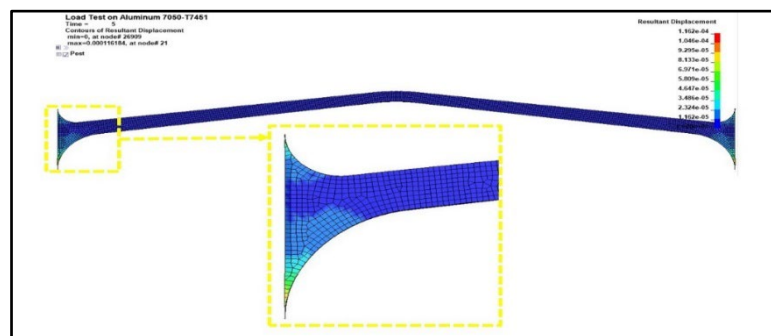
Figure 13. Without pre-stress

Figure 13 shows the displacement effect on the original structure without heat damage (no pre-stress). In comparison, Figure 14 shows the displacement effect on the original structure after heat damage (with pre-stress). Figure 15 shows the displacement of the damaged structure attached to the repair part (assembly part).

Table 3. Maximum displacement effects	
Part conditions	Displacement
Without pre stress	0 meter
With pre stress	9.60×10^{-5} meter
Assembly part	2.20×10^{-5} meter

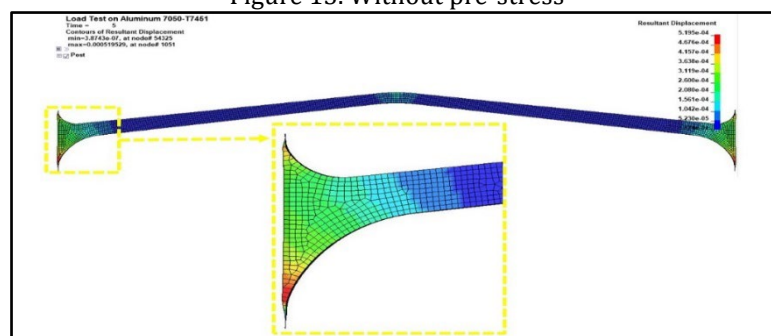
Figure 14. With pre-stress

As per Figure 16, the red graph was steady with zero displacement, due to the load applied of 40kN could not cause any displacement to the original part. Then on the green graph, the displacement incremental was the highest when used with the same load, as the material's strength had been depleted to absorb the same load. And lastly, with an additional attachment of the repair part to the damaged part, on the purple graph, the displacement incremental was lower than the green graph but still showed deformation. This can be explained that the damaged structure is transferring the load to the repair part, thus reducing the displacement effects.
